On the Ground Deformation and Phenomena Forerunning Natural Disasters (Earthquake, Rock-falling and Landslide)

By Michio TAKADA

Abstract

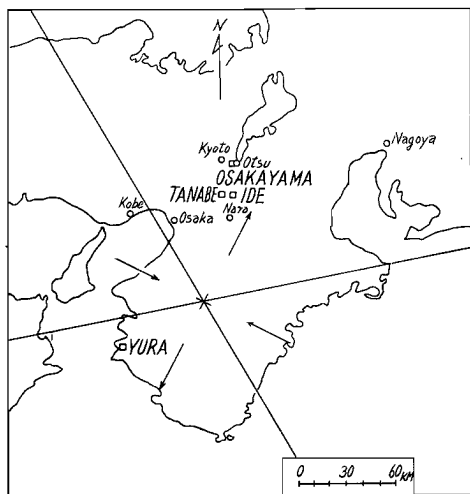
Fig. 1. Positions of the Observatories and epicentre of the Yoshino Earthquake and directions of initial ground motions in its earthquake. (The crossing full lines show the nodal lines.)

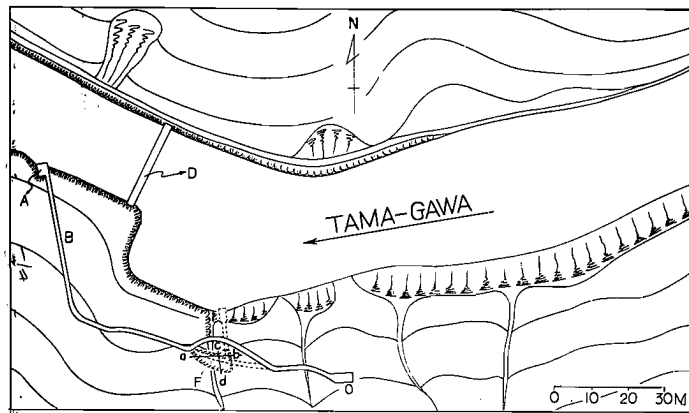
Fig. 2. Illustration of the Ide Observatory and location of rock-falling.
 A : -Recording room, B : -Drift, F : -Part of rock-falling,
 O : -Observing room, D : -Sabo-dam

On Dec. 24, 1954, a part of the drift was broken and rock-falling occurred about 15 m in the length at the Ide Observatory. (See Figs. 2 and 7.) Repair work was begun immediately but the workers were inexperienced. Fragments of fallen rocks were carried out of the drift until interrupted by an opening which came in the hillside on Jan. 17, 1955. During this work, the amount of rocks carried out was about 450 m³. After this difficult repair, the observing room could safely be entered on Jan. 31 for the first time since rock-falling. Fortunately the records before and

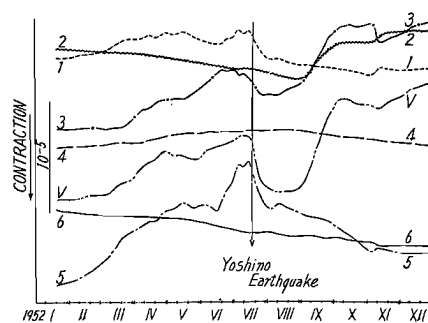
Fig. 3. Variations of linear strains and volume dilatation of which eliminated annual variations and variations caused by rainfall at Ide.

1 : -Vertical, 2 : -Horizontal·N88°E, 3 :
 -Horizontal·N2°W, 4 : -Dip 50°·N88°E,
 5 : -Dip 66°·N2°W, 6 : -Horizontal·N77°W,
 V : -Volume dilatation (1+2+3)

the Ide Observatory are shown as in Fig. 3. As this figure shows, peculiar variations were found several months before and after the earthquake-occurrence. Especially, the peculiar change is shown in the variation of extensometer-5 set up toward hypo-centre. The ground-strain gradually became large about March and it suddenly increased from the middle of June. Soon after, on July 13, just 5 days before the earthquake-occurrence, the direction of variation turned to the contrary direction, and the earthquake occurred on July 18. After that the variation of strain continued in the same direction for several months and the ground-strain recovered to some extent. The same remarkable variations of ground-strain were observed by extensometers 1 and 3 (set up nearly toward hypocentre) and shown in volume dilatation-V calculated from the record observed by extensometers 1, 2 and 3 (which were set up rectangular co-ordinate axis). The peculiar changes were not shown clearly in the other components orthogonal in the direction of hypo-centre. On the other hand, the peculiar change of ground-strain before and after the Yoshino Earthquake was also observed by Prof. I. Ozawa at the Osakayama Observatory about 20 km distance from the Ide Observatory.

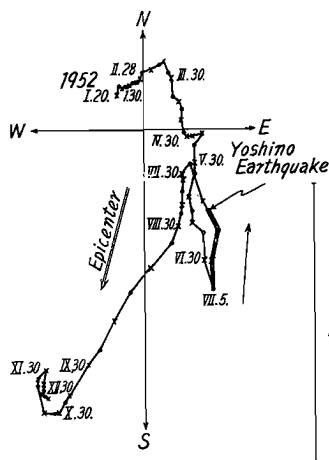
Fig. 4. Variation of ground-tilt at the Ide Observatory.

And in the case of Yoshino Earthquake some remarkable changes in ground-tilt were observed before the earthquake-occurrence. As shown in Fig. 4 the ground at Ide continued a downward tilting in an S-direction from around

March until July 5 just 13 days before the earthquake-occurrence, since then its tilting direction has turned in the contrary direction. After the earthquake-occurrence its tilting motion continued in the same direction until July 25 but since that data has turned its tilting direction in an S again. Such peculiar changes of ground-tilt were observed by Prof. I. Ozawa at the Osakayama Observatory and by Dr. K. Hosoyama at the Yura Observatory. Those observations are shown in Figs. 5 and 6, i.e. the ground-tilting direction turned on July 8 at the Osakayama Observatory and on July 2 at the Yura Observatory, and after that the Yoshino Earthquake occurred. In 1935 F. J. W. Whipple calculated

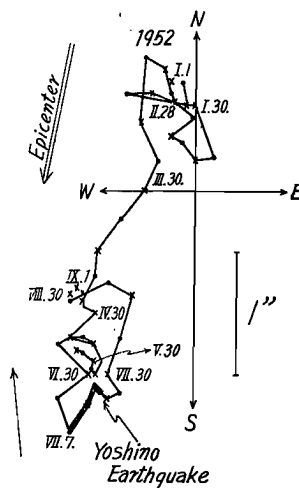
Fig. 5. Variation of ground-tilt observed at the Osakayama Observatory (by Prof. I. Ozawa).

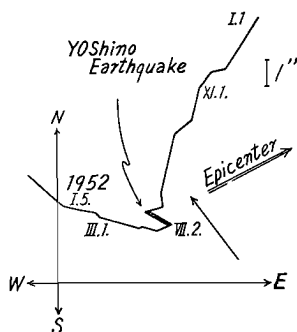
Fig. 6. Variation of ground-tilt observed at the Yura Observatory (by Dr. K. Hosoyama).

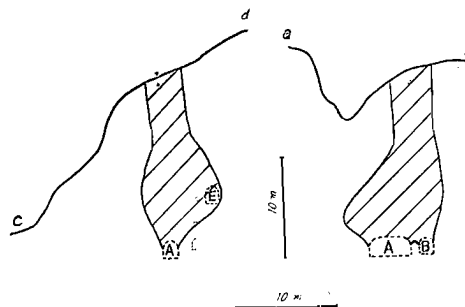
Fig. 7. Vertical sections a-b and c-d on the part of rock-falling.
A : -New drift, B : -Old drift, E : -Dead drift

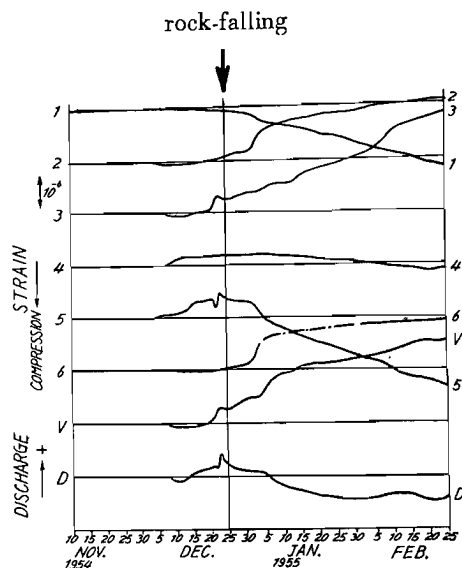
Fig. 8. Variations of ground-strain and discharge of mine water before and after the occurrence of rock-falling.

1, 2, —, 5, 6: -Linear strain, V: -Volume dilatation, D: -Discharge of mine water

after the rock-falling could be obtained due to a self-recording system. In Figs. 8 and 9, the variations of linear strains, volume dilatation and tilting (of which eliminated annual variations and secular variations) are shown. As these figures apparently show, the peculiar changes of crustal deformation are found from about Dec. 7 before the rock-fall occurred and after the rocks were carried out of the drift, those changes became bigger. From these facts, it is believed that the rocks near the rock-fall have been gradually destroy several days before rock-fall occurred. In the case of the rock-falling just as in the case of the earthquake the strain of nearby rocks changed. It is thus deduced that a rock-falling occurrence can be predicted

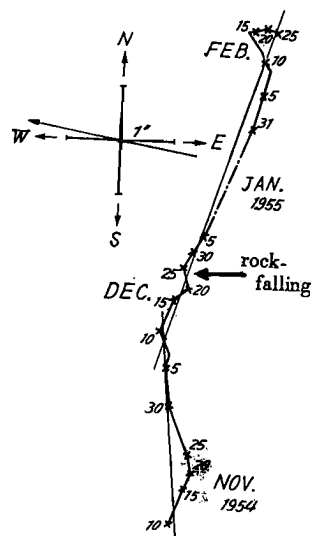
Fig. 9. Variation of ground-tilt before and after the occurrence of rock-falling. (Single arrow shows the direction to place of rock-falling.)

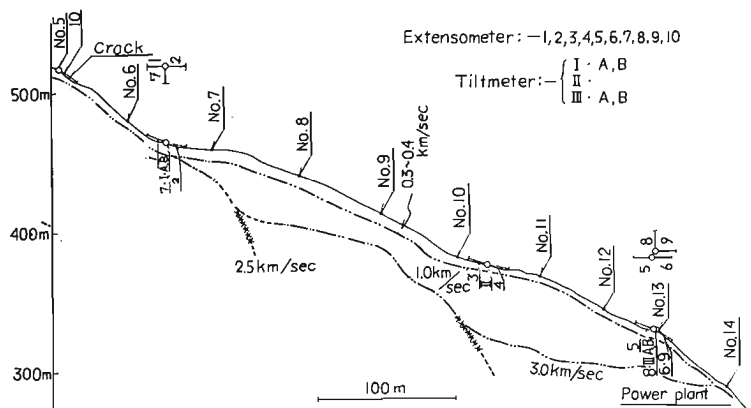
Fig. 10. Crustal structure along the penstock and disposition and distribution of the instruments. (No. 5~No. 14: -Anchor block)

First, the investigation was begun by geophysical prospecting to know the crustal structure near the penstock. Seismic prospecting was carried out mainly in the center and lower parts. As the crustal structure in the higher part was already known by seismic prospecting. The crustal structure, as found by the investigation, is shown in Fig. 10.

From this, it is believed that the zone covered on the layer with P-wave propagation velocity of 1.0 km/s is sliding. Also the shallow zone seemed to be a sliding layer therefore investigation of the propagation velocity and the damping coefficient of P-wave and S-wave was carried out to see the change according dry or wet conditions respectively. By these investigations, every characteristic and bearing power of the subsoil was made for a comparative study under each condition.

zone, observation of the ground deformation has been going on since the end of 1959. (See Fig. 10.) Those instruments were especially made for the observation of ground deformation in landslide zones and used the self-recording system. The variations of ground deformation observed by them are shown in Fig. 11. In this figure, the variations shown with — and are those of the monthly mean values obtained from daily observed values and are the running average of 13 months, monthly values. As these variation show, the changes in components 1 and 6 are larger than the others. From these facts, it is believed that the higher part near the extensometers 1 and 2, and the lower part near the steep slope zone from extensometer 6 are

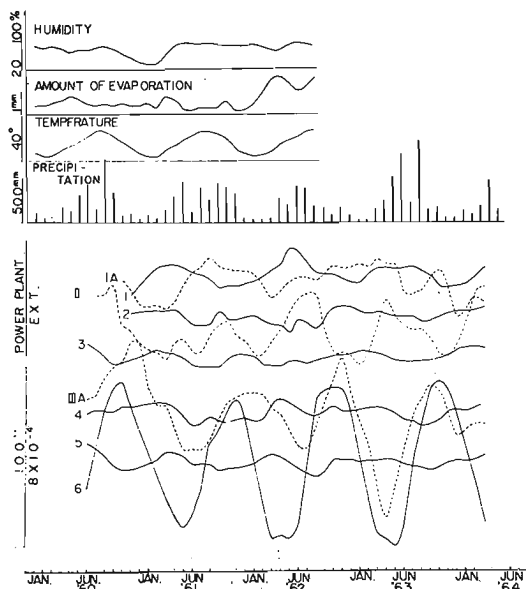
Fig. 12. Annual variations of the ground-strains (—) and the ground-tilts (---).

The annual variations of ground-strain and -tilt obtained from the observations by six extensometers and three tiltmeters which have been used from the start are as shown in Fig. 12. Generally, these variations are periodic, and the extension and contraction of the secular variation make the phase of annual variation contrary. In order to clear up the cause of the annual variation, we investigated the relationship of the meteorological

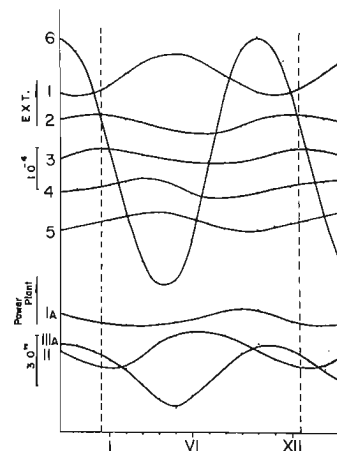
Fig. 13. Averaged annual variations of the ground-strains (1, 2, —, 5, 6) and the ground-tilts (I-A, II, III-A).

elements. It seemed to be connected to the precipitation and temperature, though it was not too clear. This problem will demand more study. Next, the average forms of annual variations for each every year are shown in Fig. 13. The most remarkable point on these variations is that the larger the amplitude of annual variation, the larger the secular variation. Therefore, when we examine landslide movement, it is dangerous to discuss after only short observation. This problem is presented in consideration of the annual variation.

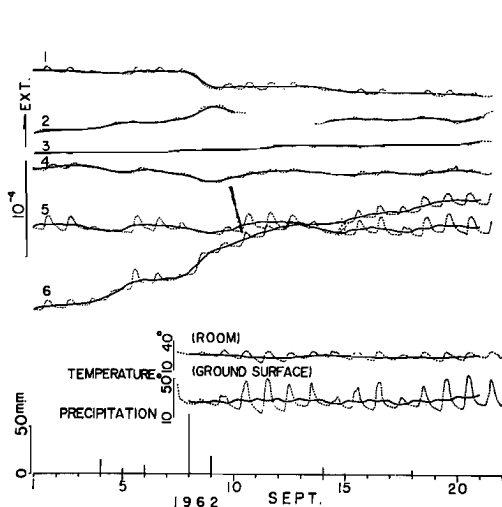
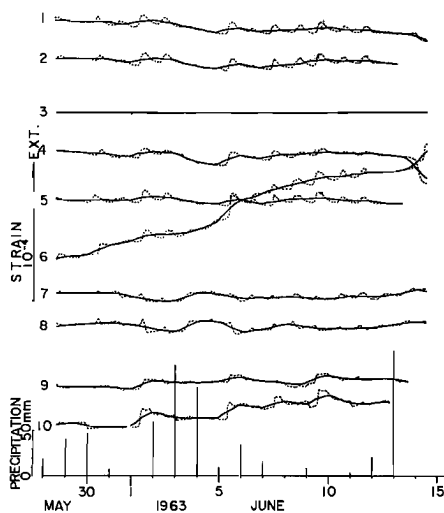
Fig. 14. Variations of the ground-strain, the temperature and the precipitation.

..... : -Observed value at every two hours,

— : -Variation of which eliminated daily variation

The variations of the ground deformation, the temperature on the ground surface, the temperature in the office of water power plant and precipitation are shown in Fig. 14 to determine on the effect of rainfall and daily variations of ground deformation. In this figure, the dotted lines show the variation of observed value every two hours and the real lines show the series of running means each 26 hours (13 observed values at every two hours). Accordingly the difference of both shows the daily variation. In Fig. 15, these daily variations are shown. In this figure, the effects of rainfall are found clearly in every component. On components 1 and 6 in which the secular variations are large, the changes caused by rainfall do not return to the preceding state but gradually accumulat. The other components in which the secular variations are small, the changes return to the preceding state several days after. Therefore whether it is an elastic characteristic or not seems to determine whether it promotes a landslide or not. On the component in which the change was caused by rainfall extension, the secular variation extended gradually. On the contrary when the change was caused by rainfall contraction, so was the secular variation. In finding the daily

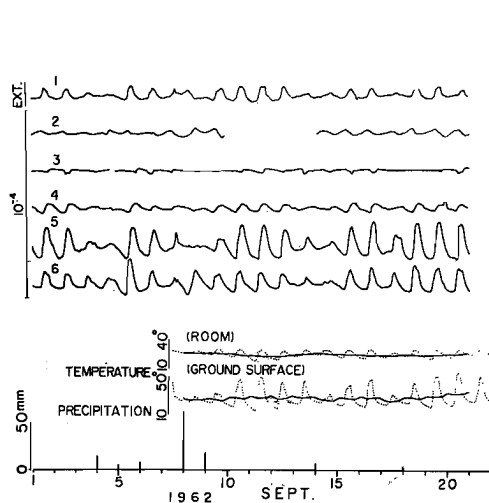
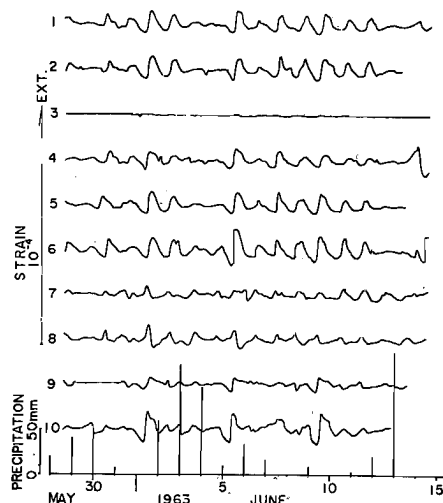
Fig. 15. Daily variations of the ground-strain, temperature and precipitation.

variations of ground deformation, it seems that they are identified with the temperature on the ground surface. Above all, it is believed that where daily variations are large secular variations are also large. It means that the ground deformation in this place is changable.

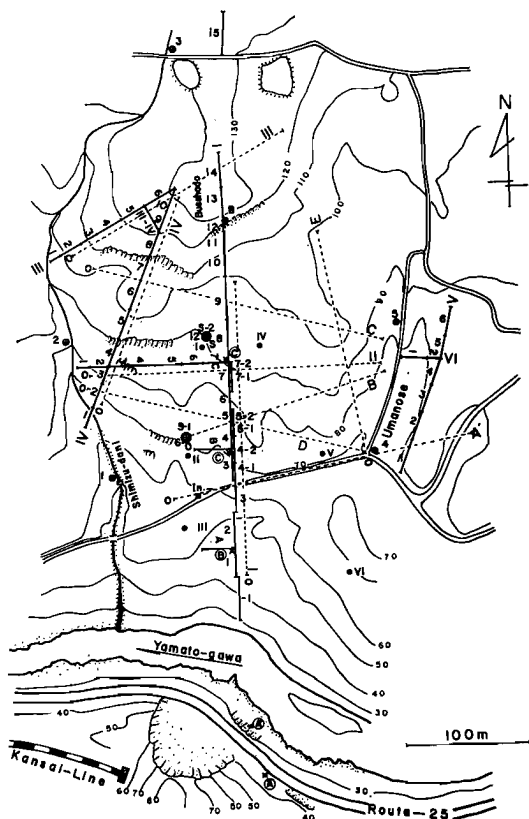
Fig. 16. Disposition and distribution of the instruments and traverse lines of seismic prospecting.
 I: -1, 1, 2,15, II: 1, 2, ---7 (=c), III: 1, 2, ---6,
 IV: 1, 2, ---10, V: 1, 2, ---6, VI: 1, 2, III-IV, A, B, S:-
 Extensometer, \times : (A), (A'), (B), (C), (C'):-Tiltmeter, \oplus : 1,
 ---5, 6, 12:-Observing well of groundwater level,
 \bullet : 1, II, ---, B:-Travelling post, In:-Portable
 underground inclinometer, \oplus S-1:-Shaft-No. 1,
 \oplus S-2:-Shaft-No. 2, ---:-Traverse line of seismic
 prospecting

First of all, seismic prospecting along 9 traverse lines shown in Fig. 16 were carried out to find the crustal structure in this area. These traverse lines were chosen so they could be compared with the results of investigation by vertical drilling. Also to know the crustal structure near the survey lines of ground-strain by the extensometers mentioned later. Late in March, 1963 (the dry season) and early in July, 1963 (the wet season), seismic prospecting was carried out along 3 traverse lines (I, A, B) by the same method. This was done to find whether each geophysical characters (seismic wave velocity, amplitude, and period, etc.) change or not in the dry and wet season. After that, about the middle of May, 1964, seismic prospecting was carried out along 6 other traverse lines (II, III, IV, C, D, E) to find the crustal structure of whole area. These results are shown in Fig. 17. As shown, in this area the zone of about 10 m in depth from the surface was a clay layer with pebble. Its propagation velocity P-wave was 0.4~0.6 km/s. The zone below was a cataclasite layer with 2.4~2.7 km/s velocity P-wave, and the fractured zone with 1.2~1.5 km/s velocity which seemed to be

their relation, the wells 1~5 (75 mm in diameter) shown in Fig. 16 were drilled in this area and the observations of water levels began in April, 1963. Especially observed were wells I, III and V which formed a regular triangle in order to determine the direction of underground stream. The ground water level indicators used in this area are the float type and the pen self-recording system. It can record 1/3 and 1/6 of the actual change. The water level of well-6, i.e. shaft No. 1 (3 m in diameter, 30 m in depth) was dug in the center of this area and used to observe the measurement. At the first observation, the ground water levels of 1, 2 and 4, 3 and 5, and 6 were about 3~4 m, 12~13 m and 29 m under the surface respectively. But after the rainfall from the beginning of May, observing wells 3 and 5 were bent by the landslide caused by long rain and the rope touched the wall of well. Therefore observations had to cease. Unfortunately, the movement of water level was too large for these indicators to observe the ground water level during the most important period. After that, shaft No. 2 was dug in July, 1963 and ground water level indicators 3 and 5 were moved to shaft No. 1 and No. 2 as No. 6 and No. 12 and the observation was begun again. But the observation for shaft No. 1 was suspended for a time because it had to be dug 15 m deeper on December 15. The result of these observations are shown in Fig. 16.

Travelling posts were also set up at I, II, ..., VI and B in order to know the movement of ground surface in this area as shown in Fig. 16. Since

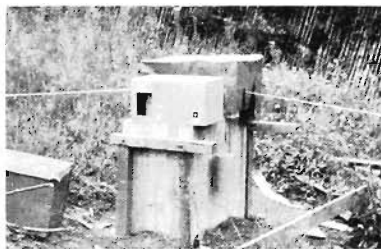
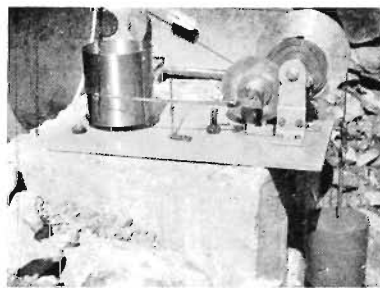
Photo. 5. Extensometer.

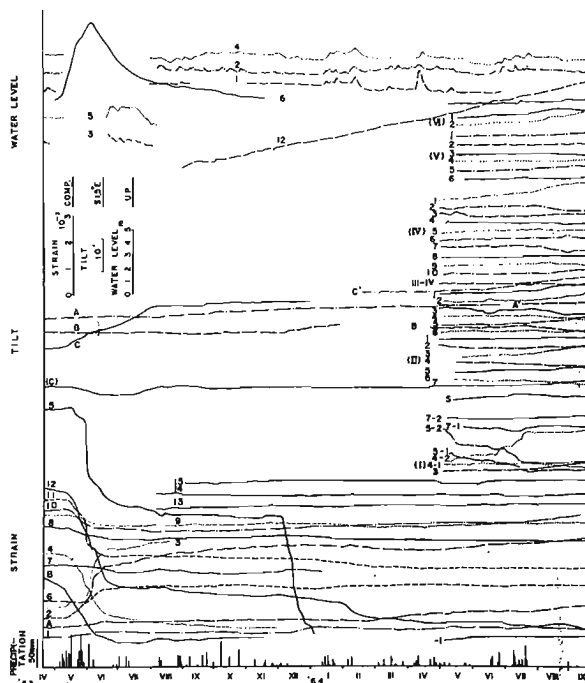
Fig. 19. Variations of the ground-strain, ground-tilt and ground water level and precipitation.

after that. If these variations are compared with the daily precipitation observed in this area (showed in the same Fig. 19), it can be found that a large variation occurred during the rainy season. Last year there was much rain, in its rainy season the total precipitation was about 600 mm. On the contrary there was little rain this year, in this season the total precipitation was only 200 mm. In addition the effect of soil mass removal appear.

Looking Fig. 19 showed above, we find that the ground deformation was affected by rainfall. The weekly average rate of changes in ground-strain, ground water level in the shaft-No. 1 and precipitation of each week in the period from April 24, 1963 to August 27 are shown in Fig. 26. Where, for example the value of April 30 is the averaged value of rate of change during a week from April 27 to May 3 in the case of ground-strain, observed value of April 30 in the case of ground water level and the total precipitation during a week before the date of April 30 (i.e. from April 24 to April 30) in the case of precipitation. From these results, each variation of ground-strain is found to be affected by rainfall, their effects are different in each place and the two have a close connection with each other, but the relation between them is complicated. The variation of water level is similar to the variation of precipitation but its variation occurs about two weeks after

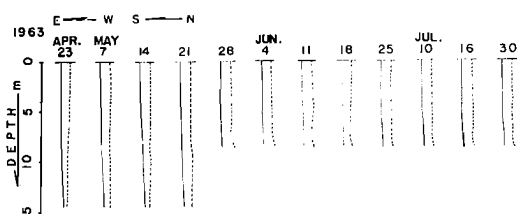
Fig. 22. Variations of the subsurface strain.
(Deformation of the vinyl chloride pipe)

but after rainfall at the beginning of May, the bend was found at 10 m. This bend became larger day by day and began to raise. At last on May 28, this instrument could not be lowered deeper than 8.5 m. This means that there was a slip surface at 8.5 m.

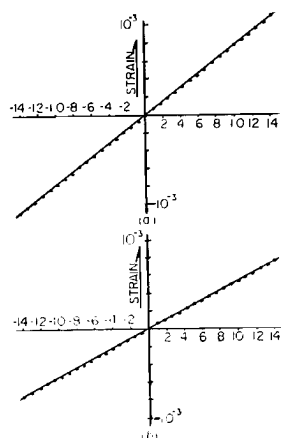
Fig. 21. Sensitivity of the portable underground inclinometer.
(Relation between the angle of inclination and strain)

strain) is shown. Where (a) is the sensitivity on upper spring and (b) is that on lower spring which directs right-angle to upper spring. In this experiment, the tilting motion in any direction was just the same to that obtained by resultant of two components.

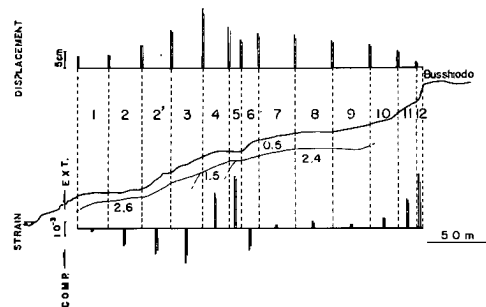
Fig. 23. Geological section along the survey line I for investigation of ground-strain, disposition of the extensometers, variations of the ground-strain and displacement of each block.

1, 2, —, 11, 12 : -Extensometer

— : -Variations of the ground-strain and the displacement from April to July
— : -Variations of the ground-strain and displacement from May 16 to June 26

Each value shows the propagation velocity of P-wave (unit : km/s). Variation of 2 is presumed from variations of 2 and 3.

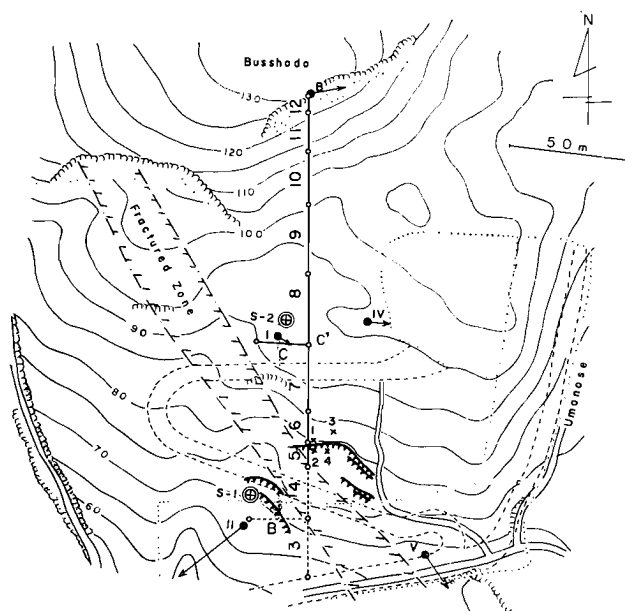
Fig. 24. Topographical map in the neighbourhood of fractured zone.

3, 4, ---, 11, 12, B, C : -Extensometer, C' : -Tiltmeter, ● -I, II, IV, V B : -Travelling post, → : -Direction of the displacement, ⊕ -S-1 : -Shaft -No. 1, ⊕ -S-2 : -Shaft -No. 2, ⌒ : -Crack, ▨ : -Area of the removal of soil mass

crashed when the older landslide was caught in this layer. This fractured zone is shown in Fig. 24 to be published later on. As shown, it passes through the steep cliff and is dis-

First, looking at the ground deformation, the effects of rainfall are remarkable as shown in Fig. 16 and these effects appeared on about May 14 about 10 days after the beginning of rainy season and continued until about June 25. In Table 1 shows the amount of strain (a), amount of contraction (b), amount of horizontal contraction (c) and horizontal displacement (d) of the fixed point on the river side of each extensometer, supposing that the fixed point of extensometer 12 on Busshōdo is a standard. IV-VII each changed from April 18, 1963 to July 31 and V-VI each changed caused by the rainfalls from May 14 to June 25. 2' is the value in the middle section of 2 and 3 which was not a extensometer, but obtained by averaging the changes of extensometers 2 and 3. According to these, in Fig. 23, the strain, horizontal displacement of each point in the geological section along the survey line of ground-strain are shown. In this figure, IV-VII are shown with — and V-VI are shown with —, and the upward change is the displacement toward the Yamoto River. From this we can understand the distribution of strains, that is, the section from the extensometer 12 on Busshōdo to the extensometer 7 is the tensile zone, the span of extensometer 6 is the compressive zone, 5 and 4 are the tensile zone and from 3 to 1 is compressive zone. The change of strain became gradually smaller (from the higher to the lower). Considering the distribution of ground-strain, the landslide block in this area is divided in two, i.e. the higher block from Busshōdo to extensometer 6 and the lower block from extensometer 5 to extensometer 1. And the sliding of the higher block is checked near extensometer 6 and the sliding of the lower block from extensometer 5 is checked at extensometers 3, 2 and 1. As the result of the seismic prospecting, it is believed that the crashed zone (P-wave propagation velocity: 1.2~1.5 km/s) gets across near extensometers 5 and 4 (See Fig. 24.) and has influence on the landsliding of the lower block.

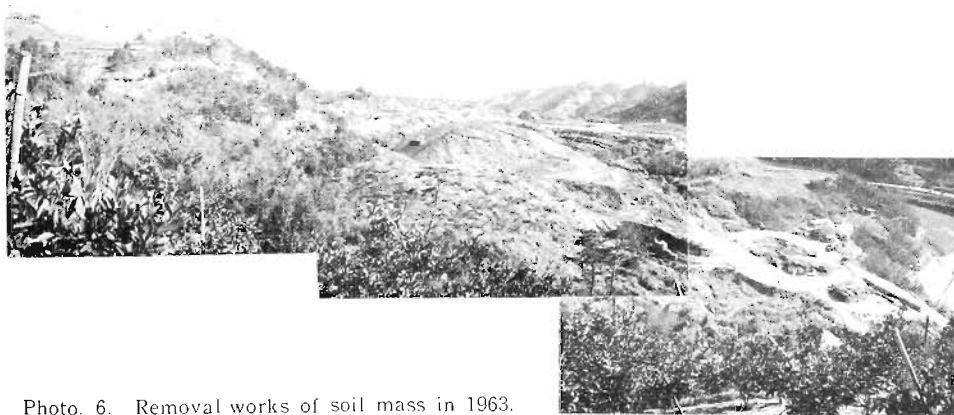
Photo. 6. Removal works of soil mass in 1963.

extensometer 3 to extensometer 1 was a compressive zone which checked the landsliding of the higher block. So much care, was taken in the removal works which have been carried on since the middle of September. The first construction was to make a transporting road which led to the National Road and the next was to cut off the slope to expand the city road near the shaft No. 1. These projects removed about 5,000 m³ soil mass to the east along the city road until the beginning of November. From the end of December to the middle of February, 1964, about 30,000 m³ soil mass in the western slope of Umanose, and from the middle of February to the end of March, about 25,000 m³ soil mass in a little hill on the east of shaft No. 2 were removed. A total of 60,000 m³ soil mass was removed. (See Photo. 6.)

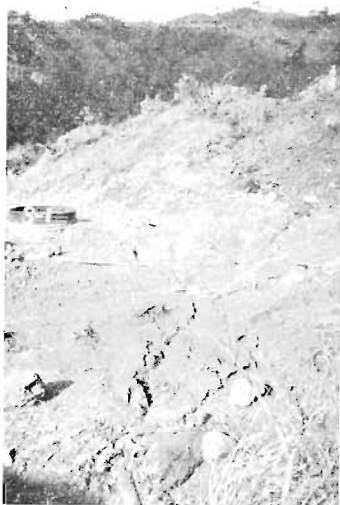
Photo. 7. Cracks occurred in the neighbourhood of Shaft No. 1.

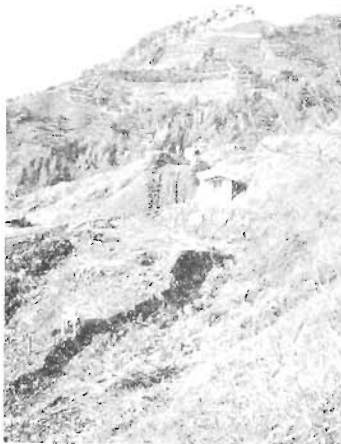
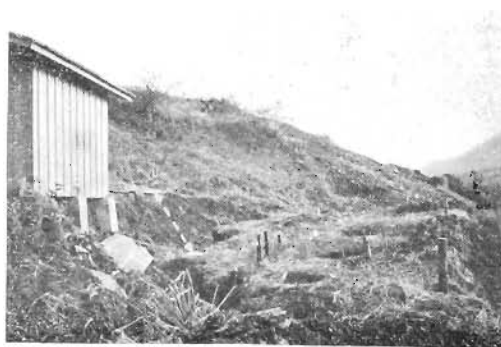
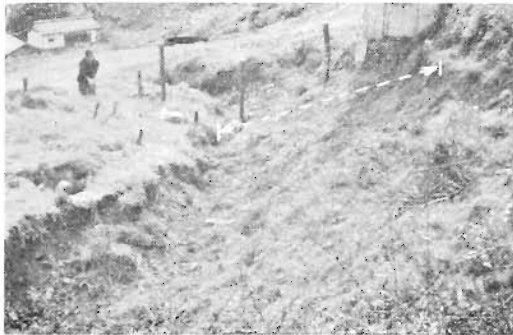
Photo. 8. Cracks occurred in the neighbourhood of extensometers 5 and 6 (On the boundary between the compressive zone and tensile zone.)

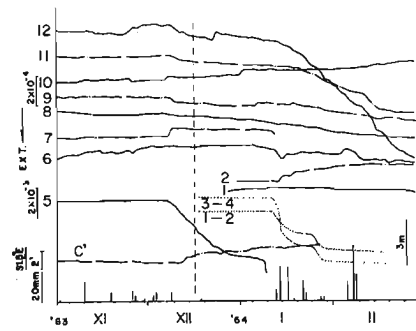
Fig. 25. Variations of ground-strain and ground-tilt before and after the crack-occurrence and the precipitation.

each other across a main crack in order to observe the variation of gap of crack. The result of these observations is shown in Fig. 25. The distances 1-2, 3-4 between these posts were suddenly extended on January 12 and they moved about 3 m during the next 5 days and increased about 1 m during the 3 days after January 25, showing the change of about 4.5 m horizontally, about 2 m vertically (See Photo. 8.), but the change has gradually decreasing since then. In Fig. 25, the variations of ground-strain and -tilt observed by extensometers and tiltmeters are shown in addition. From these variations the forerunning phenomena before the occurrence of crack (i.e. the occurrence of landslide) were observed. The extensometer 5 which crossed over the crack changed to the extension from about December 7, 10 days before the occurrence of the cracks and then the cracks occurred. After that it still continued to be tensile, but the rate of variation decreased at the end of the year. From about January 3, the rate again increased and on January 9 the observation became impossible because of the great extension. After that the gap of crack opened suddenly on January 12. Extensometer 6 set up in the compressive zone which is above to the crack showed the compression till about December 7, and after that the variation stopped for a while, but from about January 5 it changed to the extension. Extensometer 7 also showed the compression from about December 9 and after that from about January 6 it showed the extension. In these variations observed by other extensometers and tiltmeters the variation of changing rate was found before December 7 and after January 6. The ground surface was gradually deformed from about December 7 and it was broken on 17th making cracks. From about January 6, the deformation became large and was enlarged on 12th. The variation of ground-strain and -tilt occurred long before the occurrence of the landslide. So from the observations of ground-strain and -tilt the key for the prediction of landslide-occurrence may be found. In conclusion, it also seems that the landsliding of the higher block was checked

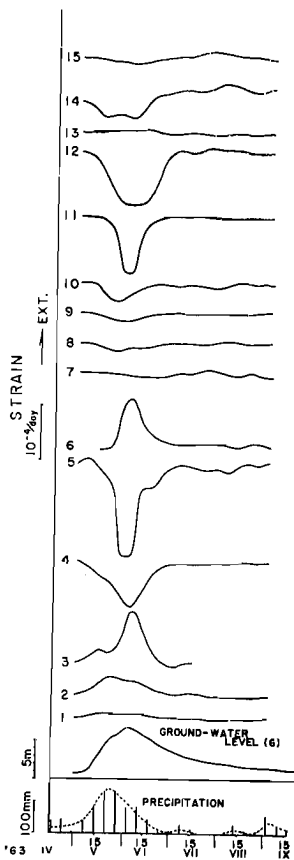
Fig. 26. Variations of the changing rate of ground-strain, the ground-water level and the precipitation of each week.

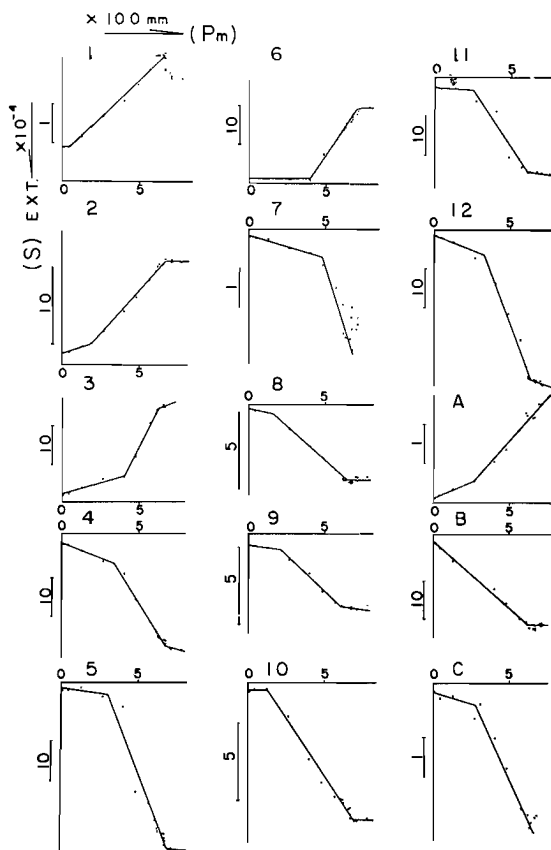
Fig. 27. Relation between the ground-strain and the successive accumulation of weekly precipitation.

the rainfall. Next, in order to study the ground-strain caused by rainfall, the relations between the successive accumulation of weekly precipitation and the ground-strain is shown in Fig. 27. From these figures we find that the ground-strain increases or decreases with the increase of the successive accumulation of precipitation. Afterward when the successive accumulation of precipitation amounted to a definite value, the variation rate of the ground-strain suddenly decreased or its variation stopped. It is believed that this phenomenon is due to the increase of the water content ratio in the soil with the permeation of water, but at last the water content quantity amounts to the saturation point. G. Kajikawa has tried to obtain the relationship between the moisture ratio (%) and the internal frictional angle (ϕ) and between the moisture ratio (%) and the cohesion (c) on the soil in that area. (See Fig. 28.) According to this report, after the water content ratio increased more than some value, ϕ and c became suddenly small and the soil inherited the plasticity. So it is believed that the results of the variation in the water content ratio of soil, (caused by rainfall) and the form of slip surface etc. complicate each other. At this point a landslide occurs and the ground strains. Accordingly, it is considered that the ground-strain does not change much when there is not as much rain as in the rainy season of 1964.

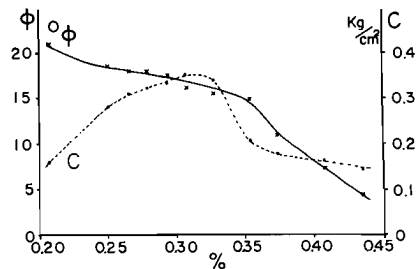
Fig. 28. Relation between the moisture ratio (%) and the internal frictional angle (ϕ) and the moisture ratio and the cohesion (c) on Kamenose soil. (after G. Kajikawa)
